October 12, 2017

This alert is based on information from the National Medication Errors Reporting Program operated by the Institute for Safe Medication Practices.

Severe hyperglycemia in patients incorrectly using insulin pens at home

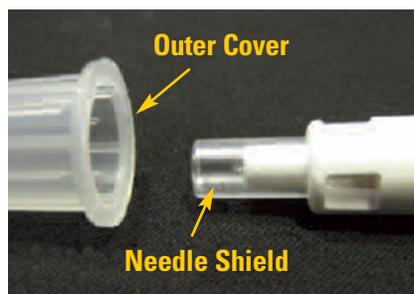
Safety Pen Needle

With the NovoFine Autocover (**Figure 1**) safety needle for example, the user holds the outer cover of the needle while it is attached to the insulin pen and then removes it, exposing a plastic needle shield that covers the needle. During administration, as the device is held against the skin and pressure is applied, the needle shield slides back to allow the skin to be punctured and the insulin to be injected once the dose button is pressed. As the needle is removed from the skin after administration, the shield slides back over the needle. The needle is hidden throughout the process so the patient will never see it.

Figure 1. NovoFine Autocover is an example of insulin pen needle with a needle shield that automatically retracts upon injection and re-covers and locks over the needle when withdrawn from the skin. (BD AutoShield Duo, not pictured here, is another example of a safety needle used with pens.)

The Autocover safety needle system is different from standard insulin pen needles widely used by patients in the home, which do not employ an automatic needle shield. These standard needles are available from brand and generic manufacturers. Because standard pen needles and those with an automatic needle shield may look similar, patients may not be aware of the differences in preparation for administration. Both the automatic safety needle and standard needle systems have a larger outer protective cover that, when removed, exposes either a retractable needle shield (**Figure 1**) or a plain inner needle cover (**Figure 2**). The automatic safety needle shield is

not intended to be removed prior to injection, **but the inner needle cover on the standard needle system must be removed before the injection** to allow the administration of insulin.

Patients using insulin pens with automatic needle retraction devices while hospitalized, but who will be using standard pen needles at home, must be made aware that the standard needle is different. It is imperative that removal of **BOTH** covers is explained to patients during diabetes education as depicted in this video: www.myclickfine.com/clickfine-overview.html. Prior to injection, the pen should be “primed” using 2 to 3 units of insulin to make certain that the needle is correctly attached and to remove any air bubbles or pockets in the insulin cartridge. This is known as an ‘air shot’ or safety shot, and the patient should see about 2 drops of insulin come out of the needle. If no insulin appears after two or three attempts, the needle should be tightened or changed until a drop of insulin appears. If a patient continues to see no drops, they might have failed to remove the inner needle cover and will likely bypass this step prior to injection.

- Teach all patients receiving an insulin pen how to use it properly, and require a return demonstration to verify understanding.
- Verify which pen needle the patient will be using at home, and tailor the training to that needle. One

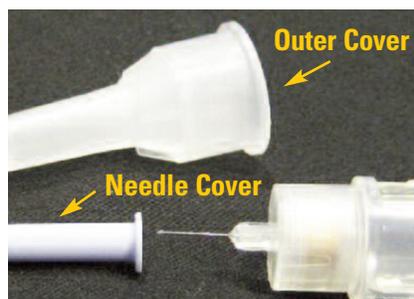
Standard Pen Needle

Figure 2. BD Ultra-fine III is an example of a standard pen needle. Both the outer cover and inner needle cover must be removed prior to injection.
